**Flood Control Project Maintenance  
Levee Inspections**

**Fall 2018 Levee Maintenance Deficiency Summary Report**

**Flood Control Project Maintenance  
Levee Inspections****LMA District Cover Sheet****Fall 2018 Levee Inspection Results****Reclamation District No. 0501 Ryer Island**

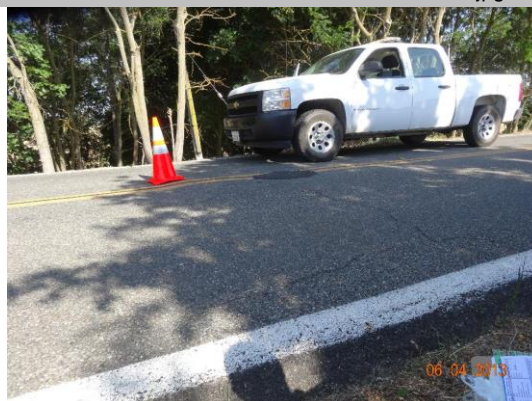
Photo 1 of 3 : UCIP\_FA\_2018\_53350\_58923.jpg

UCIP Comments: 07/24/2018 Same as last inspection. Appears not in use; WS appears not in use due to pipe disconnection, but cannot confirm based on LS connections being intact. PVC pipe sleeved through levee, so downgrading to Non-Urgent. Recommend internal pipe inspection (D. Sanoski - DWR UCIP).8/22/2016 Sacramento County has re-paved road and patch is no longer present. Crossing remains to be Urgent due to the unknown condition of the section of the levee along pipe alignment. Unable to determine if any internal erosion is present along pipe. According to LMA representative, Stacy Boyd, no additional sink holes have developed since 2013. No sink holes have been noticed since PVC pipe was sleeved through existing steel pipe. Permit authorizing work is not available. Need to identify current owner. Owner will need to coordinate with CVFPB to remove or abandon crossing per Title 23 requirements. (DWR UCIP - omagana)6/04/2013 Damage present on levee crown--unable to confirm if damage due to leak in pipe. Signs of repair work on crown, however, no permit found to document recent damage to levee or repair work. New PVC pipe has been sleeved through the existing 6-inch pipe. Unable to determine if crossing is still in use, if not, crossings needs to be removed according to CVFPB Title 23 requirements. (DWR UCIP - omagana)

View of crown at crossing.

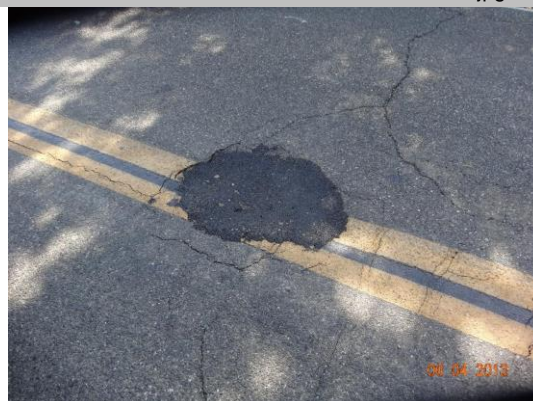
Photo 2 of 3 : UCIP\_FA\_2018\_53350\_58922.jpg

Comment Code						
Inspector Comment						
FS_ID:53350 DS_ID:21030 EP_NO: 4581 Repair Type: Non-Urgent Crossing Status: Found UCIP Comments: 07/24/2018 Same as last inspection. Appears not in use; WS appears not in use due to pipe disconnection, but cannot confirm based on LS connections being intact. PVC pipe sleeved through levee, so downgrading to Non-Urgent. Recommend internal pipe inspection (D. Sanoski - DWR UCIP).8/22/2016 Sacramento County has re-paved road and patch is no longer present. Crossing remains to be Urgent due to the unknown condition of the section of the levee along pipe alignment. Unable to determine if any internal erosion is present along pipe. According to LMA representative, Stacy Boyd, no additional sink holes have developed since 2013. No sink holes have been noticed since PVC pipe was sleeved through existing steel pipe. Permit authorizing work is not available. Need to identify current owner. Owner will need to coordinate with CVFPB to remove or abandon crossing per Title 23 requirements. (DWR UCIP - omagana)6/04/2013 Damage present on levee crown--unable to confirm if damage due to leak in pipe. Signs of repair work on crown, however, no permit found to document recent damage to levee or repair work. New PVC pipe has been sleeved through the existing 6-inch pipe. Unable to determine if crossing is still in use, if not, crossings needs to be removed according to CVFPB Title 23 requirements. (DWR UCIP - omagana) FIELD_STRUCT_DESC: *ABANDONED* 6-inch steel irrigation discharge pipe through the levee, 2.5 feet below the crown. 2-inch steel electrical conduit through the levee, at an unknown depth. Cutoff wall around the pipe at the center of the levee. Pump and gate valve in a pump house on the waterside (WS) slope. Service pole on the landside (LS) slope. Pipe is exposed on each slope. (Plans for removing and replacing an irrigation pipe through the levee authorized under Permit No. 4581, 1964 - Walter Light). [Additional Reference(s): DWR Levee Log, 2005. USACE Sacramento O&M Manual 105, April 1959, (HLM 0.2), 7-inch pipe, 2.6 feet below the crown, referenced]. FS Date: 7/24/2018 11:20:00 AM

Subsidence and patch work repair on crown.

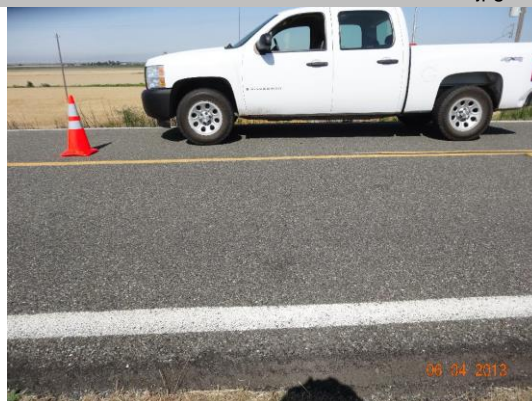
Photo 1 of 3 : UCIP\_FA\_2018\_32524\_58928.jpg

Comment Code						
Inspector Comment						
FS_ID:32524 DS_ID:21031 EP_NO: N/A Repair Type: Non-Urgent Crossing Status: Found UCIP Comments: Dense vegetation limits the inspector's visibility to identify signs of leaks through the slope. Recommend removing vegetation along pipe alignment for reinspection. Need to contact the owner to clear slope along crossing. FIELD_STRUCT_DESC: 20-inch irrigation discharge pipe of an unknown material and a 2.5-inch electrical conduit of an unknown material through the levee, both 7.8 feet below the crown. Pump and gate valve in a pump house on the landside (LS) slope. Pipe exposed along the waterside (WS) slope. [Additional Reference(s): DWR Levee Log, 2005. USACE Sacramento O&M Manual 105, April 1959, (HLM 0.4), irrigation siphon referenced]. FS Date: 6/4/2013

View of crown

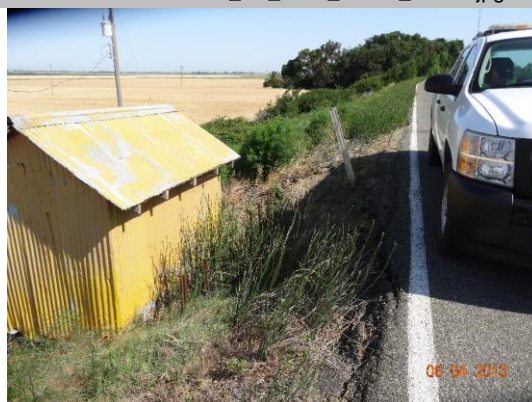
Photo 2 of 3 : UCIP\_FA\_2018\_32524\_58927.jpg

Overview of landside. Pump house and power pole visible on landward side.

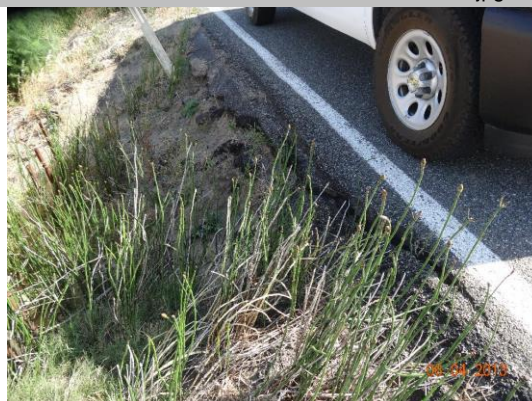
Photo 3 of 3 : UCIP\_FA\_2018\_32524\_58925.jpg

Comment Code						
Inspector Comment						
FS_ID:32524						
DS_ID:21031						
EP_NO: N/A						
Repair Type: Non-Urgent						
Crossing Status: Found						
UCIP Comments: Dense vegetation limits the inspector's visibility to identify signs of leaks through the slope. Recommend removing vegetation along pipe alignment for reinspection. Need to contact the owner to clear slope along crossing.						
FIELD_STRUCT_DESC: 20-inch irrigation discharge pipe of an unknown material and a 2.5-inch electrical conduit of an unknown material through the levee, both 7.8 feet below the crown. Pump and gate valve in a pump house on the landside (LS) slope. Pipe exposed along the waterside (WS) slope. [Additional Reference(s): DWR Levee Log, 2005. USACE Sacramento O&M Manual 105, April 1959, (HLM 0.4), irrigation siphon referenced].						
FS Date: 6/4/2013

Crown hinge point damaged, roadway section missing.

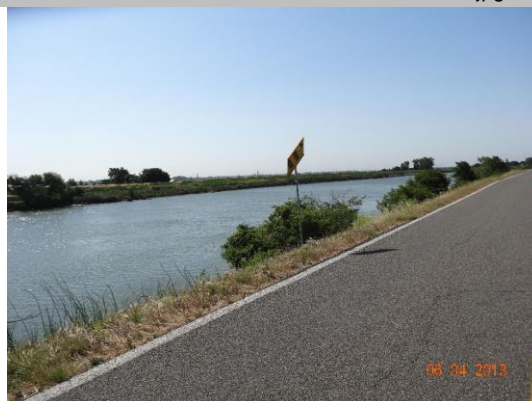
Photo 1 of 3 : UCIP\_FA\_2018\_41409\_58931.jpg

Comment Code						
Inspector Comment						
FS_ID:41409 DS_ID:21032 EP_NO: N/A Repair Type: Non-Urgent Crossing Status: Found UCIP Comments: Need to contact owner and ask for emergency contact information and permit number. 8/21/13 Contacted Gas Control Division under the emergency contact No. 1-877-723-3344. Message has been forward to Brian Habersack at 916-859-4700, email: bhabersack@gasbiz.com. FIELD_STRUCT_DESC: 6-inch steel natural gas pipeline under the levee, 60 feet below the crown. Gas line marker on each shoulder. (Plans to install a 6-inch steel natural gas pipeline across and bored under the channel and each levee authorized under Permit No. 17033, 1999 - Delta Gas Gathering, Inc., and A. A. Production Services, Inc.). [Additional Reference(s): DWR Levee Log, 2005]. FS Date: 6/4/2013

Overview of waterside at crossing. Marker on shoulder.

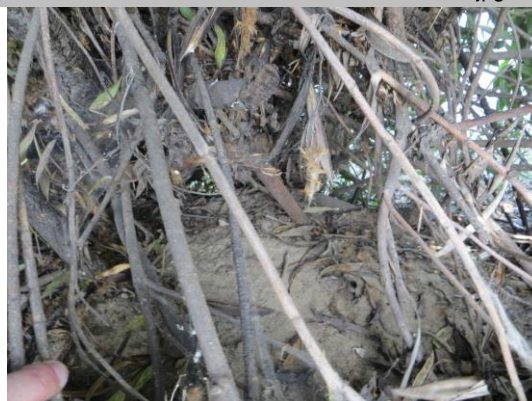
Photo 1 of 3 : UCIP\_FA\_2018\_44643\_73842.jpg

Comment Code					
Inspector Comment					
FS_ID:44643 DS_ID:21089 EP_NO: 2683 Repair Type: Non-Urgent Crossing Status: Indicator Found UCIP Comments: Appears abandoned and if so should be done so properly. FIELD_STRUCT_DESC: *ABANDONED* 2-inch steel water pipe and a 1-inch steel electrical conduit through the levee, both 3 feet below the crown. Portion of pipe visible under the oleanders on the landside (LS) shoulder, may be part of this crossing. No evidence remains on the waterside (WS) slope. (Plans for installation of an electrical conduit and a water pipe through the levee authorized under Permit No. 2683, 1957 - John Gosner). FS Date: 4/21/2015

Pipes visible under oleander on LS shoulder.

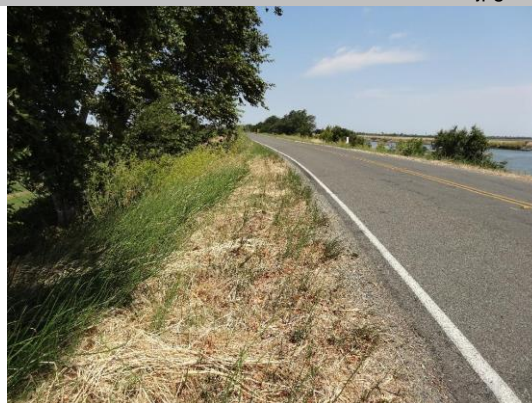
Photo 1 of 3 : UCIP\_FA\_2018\_50020\_75648.jpg

Comment Code					
Inspector Comment					
FS_ID:50020 DS_ID:21034 EP_NO: N/A Repair Type: Non-Urgent Crossing Status: Found UCIP Comments: 8/22/2016 Crossing has been downgraded from Urgent to Non-Urgent -- no evidence of damage to levee is present. Dense vegetation limits the inspector's visibility to identify signs of pipe failure (leaks) through he slope. Recommend removing vegetation along pipe alignment to conduct proper inspection of structure and appurtenances. Also will need to coordinate with owner to determine if permit was obtained for the modifications made to crossing (PVC pipe sleeved through existing pipe). (DWR UCIP - omagana)4/21/2015 Unauthorized PVC pipe. Annular space not grouted. 14-inch pipe open on both ends. (DWR UCIP - omagana) FIELD_STRUCT_DESC: 14-inch steel irrigation siphon pipe through the levee, 3.2 feet below the crown. 10-inch polyvinyl chloride (PVC) pipe sleeved through the 14-inch pipe. Siphon breaker on the landside (LS) shoulder. [Additional Reference(s): DWR Levee Log, 2005. USACE Sacramento O&M Manual 105, April 1959, (HLM 1.0)]. FS Date: 8/22/2016

View of levee crown and LS shoulder.

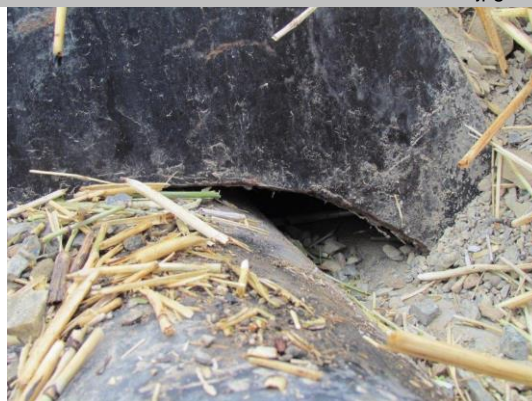
Photo 3 of 3 : UCIP\_FA\_2018\_47516\_75034.jpg

Comment Code						
Inspector Comment						
FS_ID:47516 DS_ID:21086 EP_NO: 13233 Repair Type: Non-Urgent Crossing Status: Found UCIP Comments: Annular space between pipes not grouted. FPIIB Inspector Herman Phillips will contact owner regarding lack of permit for sand filters. Steel plate partially covers openings between pipes. FIELD_STRUCT_DESC: 14-inch coated steel irrigation discharge pipe through the levee, 2.5 feet below the crown. 8-inch steel pipe sleeved through the 14-inch pipe. Cutoff wall around the pipe at the center of the levee. Pump and check valve in a pump house on the waterside (WS) slope. Service pole on the landside (LS) slope. A 1.5-inch and a 2.5-inch electrical conduits at the same location. Siphon breaker on each shoulder. (Plans to replace a 12-inch irrigation pipe through the levee authorized under Permit No. 11813, 1976 - Harry H. Rasmussen. Plans to replace irrigation pipe with a 14-inch pipe through the levee authorized under Permit No. 13233, 1981 - Harry H. Rasmussen. Plans to install an 8-inch steel pipe through an existing 14-inch pipe through the levee authorized under Permit No. 11813-1, 2013 - Matt Davis). FS Date: 4/21/2015

LS: (photo from FPIIB Inspector H. Phillips) Annular space not grouted.

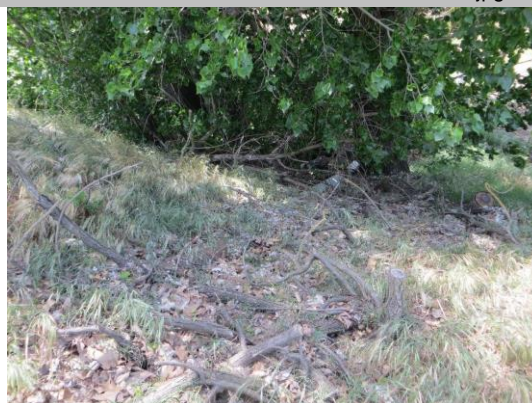
Photo 1 of 3 : UCIP\_FA\_2018\_44683\_73882.jpg

Pipe visible on LS slope.

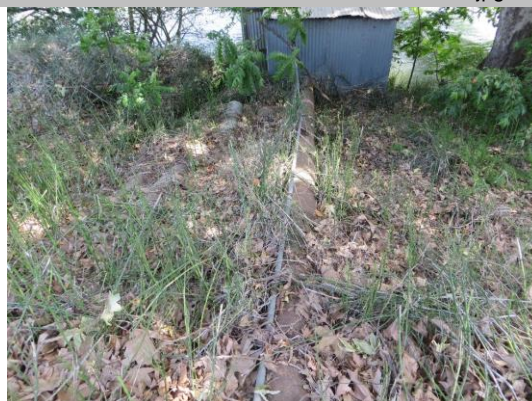
Photo 2 of 3 : UCIP\_FA\_2018\_44683\_73881.jpg

Pipe and pump house on WS slope.

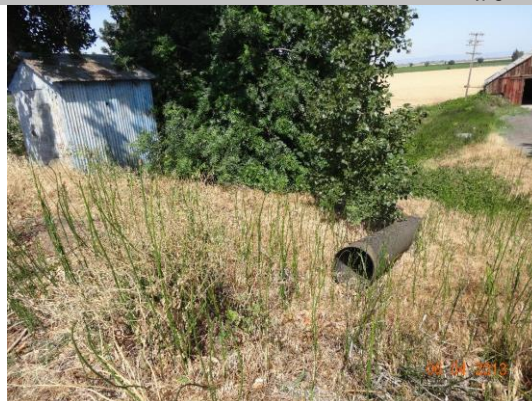
Photo 2 of 3 : UCIP\_FA\_2018\_32526\_58935.jpg

Pump house on landward slope. An abandoned pipe section on landward slope.

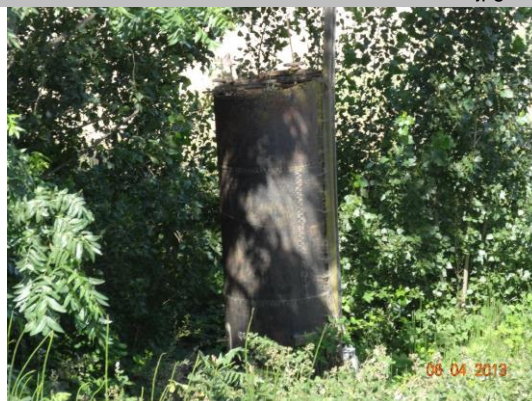
Photo 3 of 3 : UCIP\_FA\_2018\_32526\_58934.jpg

Standpipe on landward toe.

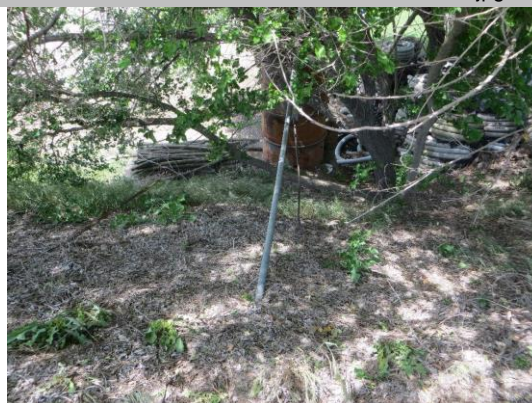
Photo 1 of 2 : UCIP\_FA\_2018\_44688\_73891.jpg

Pipe visible at LS shoulder. Pipe connects to top of steel standpipe at LS toe.

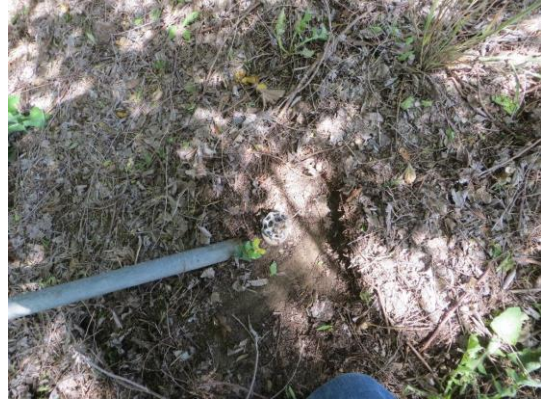
Photo 2 of 2 : UCIP\_FA\_2018\_44688\_73890.jpg

Shutoff valve at LS shoulder.

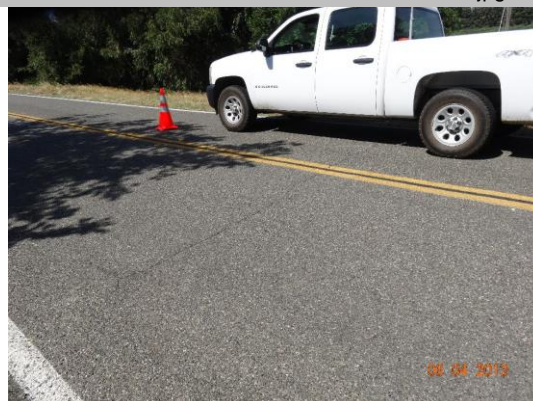
Photo 1 of 3 : UCIP\_FA\_2018\_53351\_58942.jpg

View of levee crown at crossing. Single line crack on levee crown.

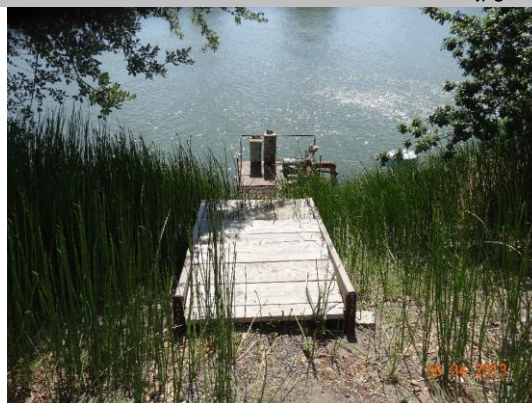
Photo 2 of 3 : UCIP\_FA\_2018\_53351\_58940.jpg

Station details--gate valve, air vent, and other appurtenances.

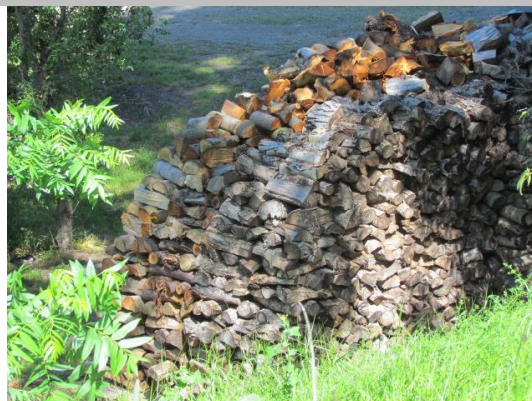
Photo 2 of 2 : FA\_2018\_RD0501\_169\_63\_20180925\_00012.jpg

RD 501 Unit 1 levee mile 3.24 landside toe.

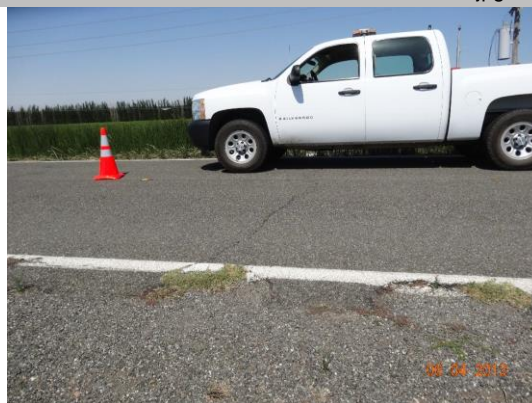
Photo 1 of 3 : UCIP\_FA\_2018\_32529\_58954.jpg

Single line crack on crown.

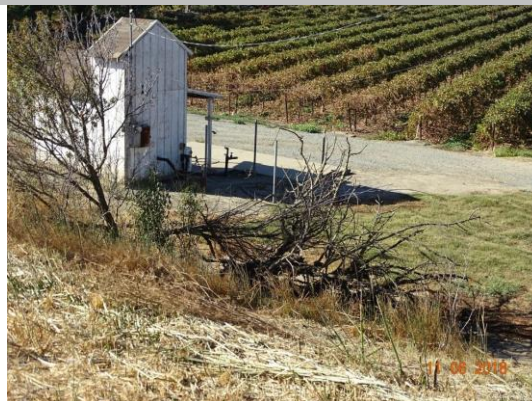
Photo 1 of 1 : FA\_2018\_RD0501\_169\_61\_20181106\_00068.jpg

View of down tree on the land side toe (November 2018).

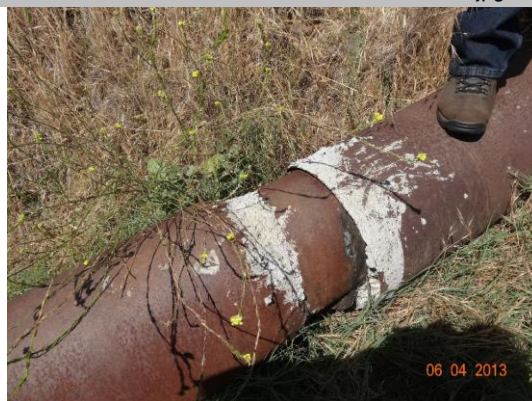
Photo 3 of 3 : UCIP\_FA\_2018\_19644\_33326.jpg

12-inch pipe sleeved through existing 14-inch pipe, and annular space grouted--waterward side.

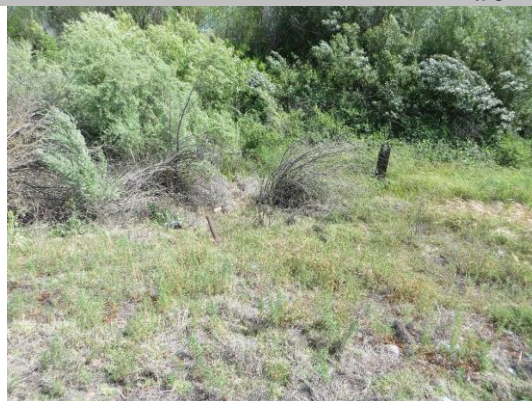
Photo 2 of 3 : UCIP\_FA\_2018\_50024\_73900.jpg

2.5-inch conduit visible on WS slope.

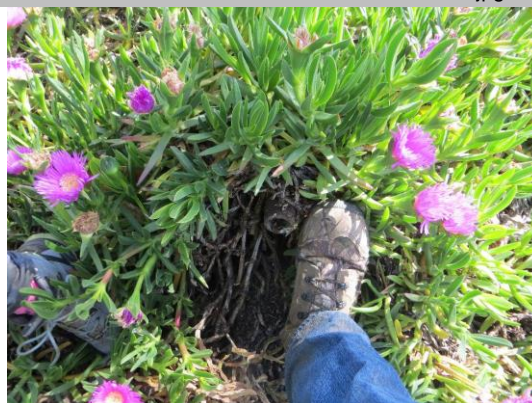
Photo 1 of 3 : UCIP\_FA\_2018\_44720\_73904.jpg

Pipe visible on LS slope. Succulants mound up over pipe.

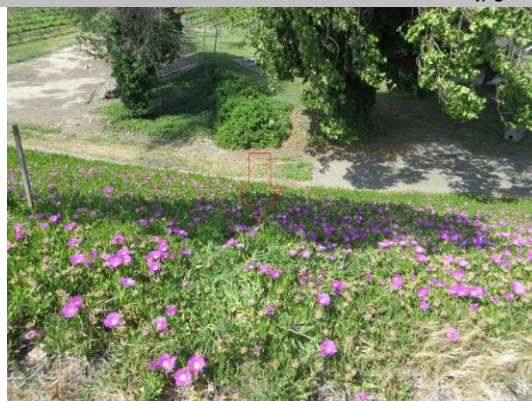
Photo 2 of 3 : UCIP\_FA\_2018\_44720\_73903.jpg

Mound at pipe visible on LS slope.

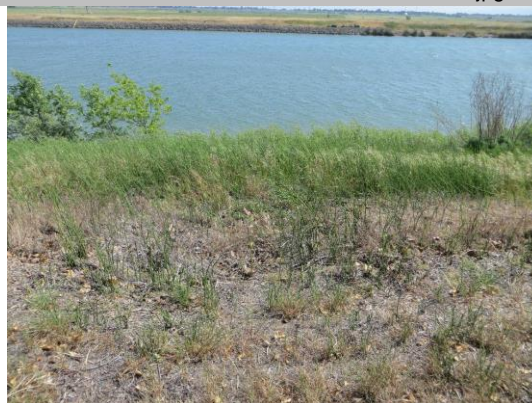
Photo 3 of 3 : UCIP\_FA\_2018\_44720\_73902.jpg

Depression on WS shoulder across from pipe may be a good indicator of pipe location.

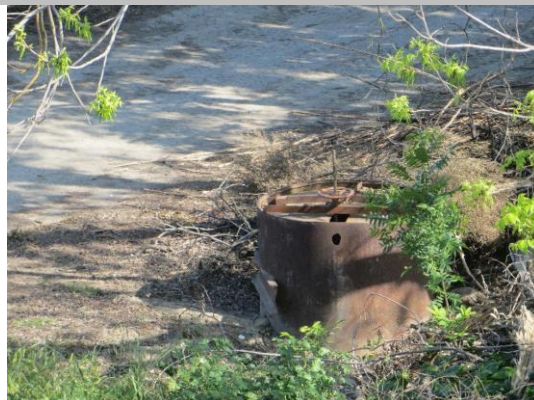
Photo 2 of 3 : UCIP\_FA\_2018\_44726\_73921.jpg

Steel standpipe and gatevalve on LS toe.

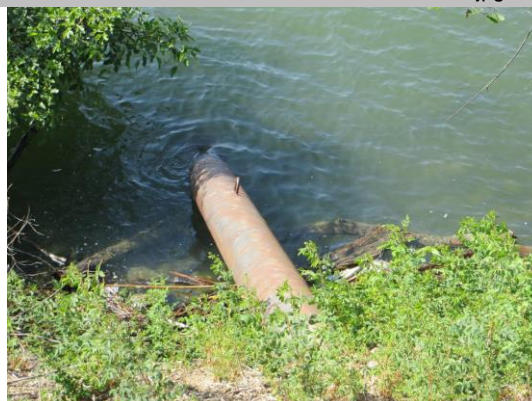
Photo 3 of 3 : UCIP\_FA\_2018\_44726\_73920.jpg

Pipe visible on WS toe.

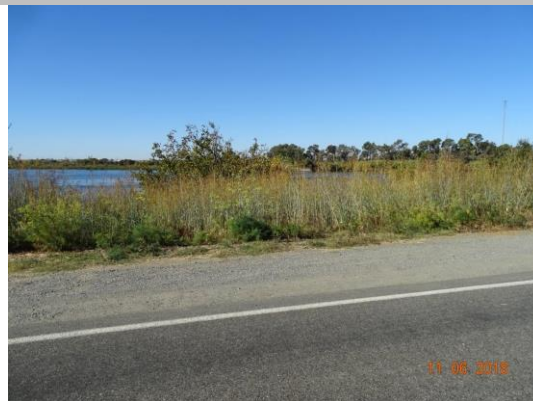
Photo 1 of 1 : FA\_2018\_RD0501\_170\_17\_20181106\_00042.jpg

View of thick vegetation at the top of the water side slope (November 2018).

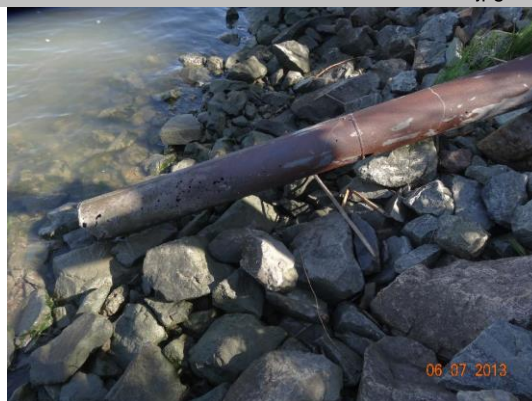
Photo 3 of 3 : UCIP\_FA\_2018\_53353\_58966.jpg

Deteriorated pipe with visible holes through pipe wall.

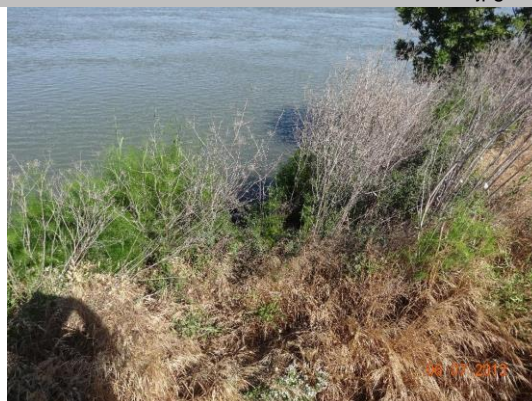
Photo 3 of 3 : UCIP\_FA\_2018\_53354\_58969.jpg

View of waterward side--dense vegetation limits inspection. Unable to locate pipe on waterward side.

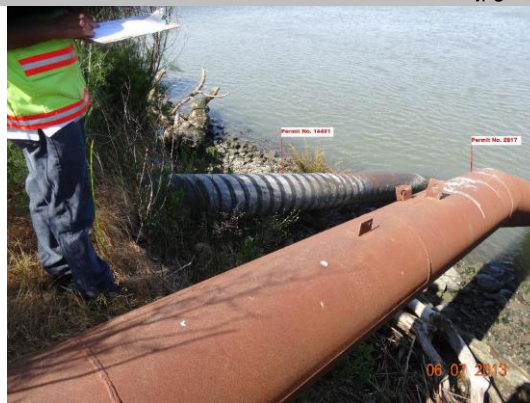
Photo 3 of 3 : UCIP\_FA\_2018\_44865\_58974.jpg

Waterward side--2-24 inch pipe inlets.

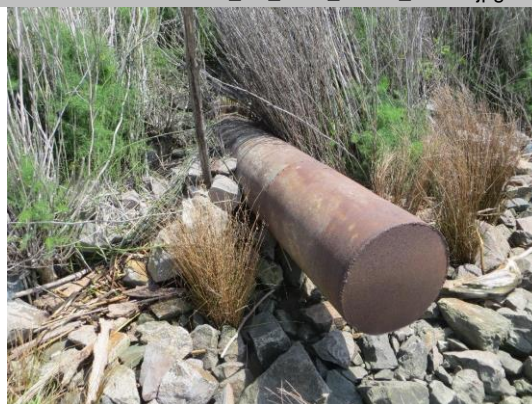
Photo 1 of 3 : UCIP\_FA\_2018\_44753\_73955.jpg

20-inch pipe with welded steel plate over end on WS toe.

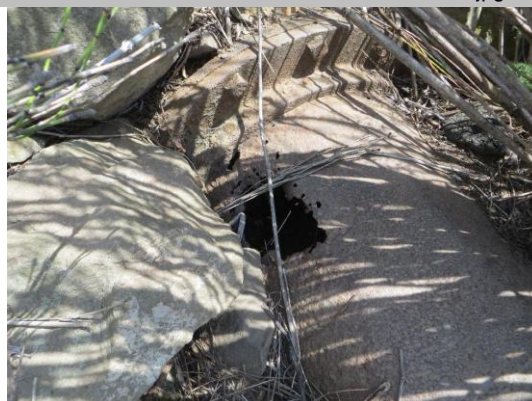
Photo 2 of 3 : UCIP\_FA\_2018\_44753\_73954.jpg

Hole in pipe at WS toe.

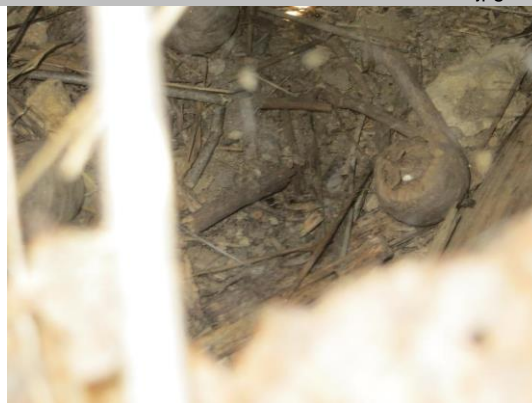
Photo 3 of 3 : UCIP\_FA\_2018\_44753\_73953.jpg

Inside hole in pipe at WS toe.

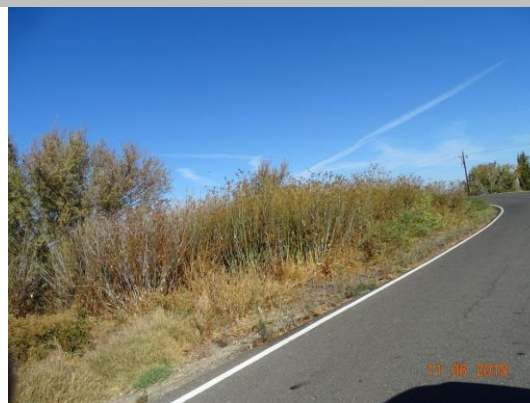
Photo 1 of 1 : FA\_2018\_RD0501\_170\_18\_20181106\_00043.jpg

View looking upstream at vegetation on the water side shoulder (November 2018).

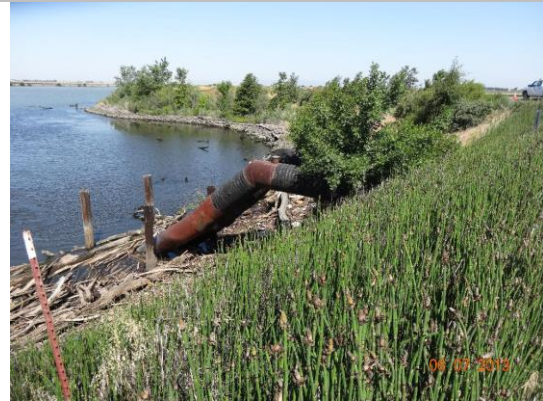
Photo 3 of 3 : UCIP\_FA\_2018\_47049\_33374.jpg

View of exposed pipe section on waterward side.

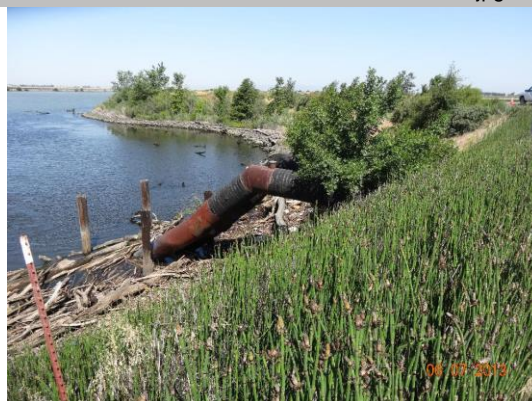
Photo 3 of 3 : UCIP\_FA\_2018\_47050\_33368.jpg

View of 36 inch pipes exposed on waterward side.

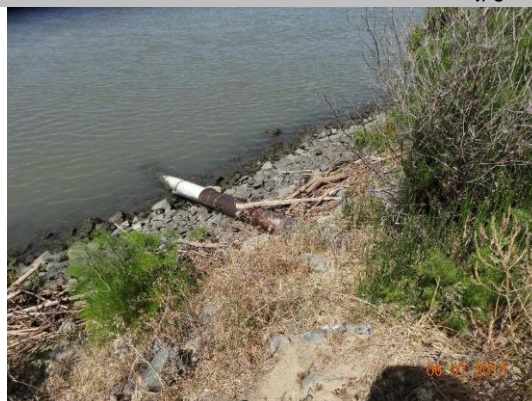
Photo 3 of 3 : UCIP\_FA\_2018\_32537\_58988.jpg

View of exposed section of pipe at waterward toe.

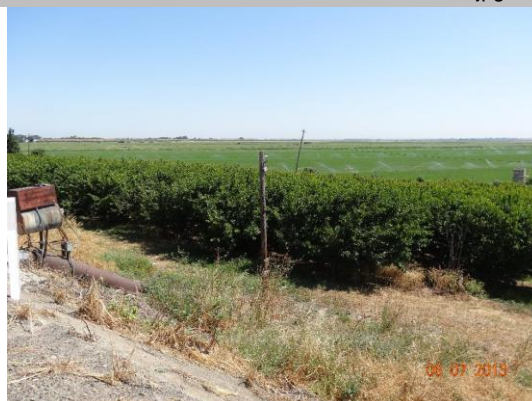
Photo 3 of 3 : UCIP\_FA\_2018\_44872\_33391.jpg

Overview of landward side. Pump system located near crown hinge point.

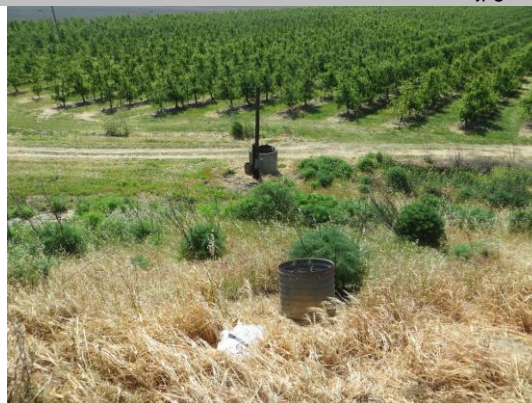
Photo 1 of 2 : UCIP\_FA\_2018\_44728\_73924.jpg

Siphon breaker in 24-inch CMP riser on LS slope. Standpipe visible at LS toe.

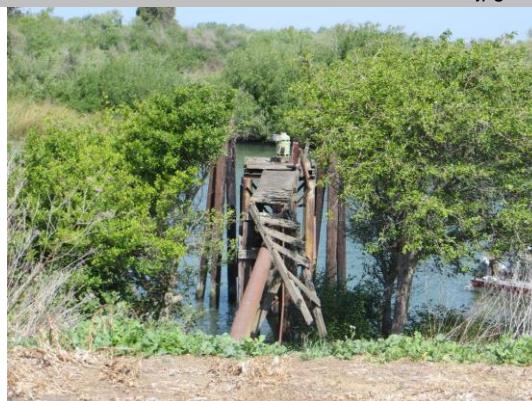
Photo 2 of 2 : UCIP\_FA\_2018\_44728\_73923.jpg

Pump on wooden pier off WS toe.

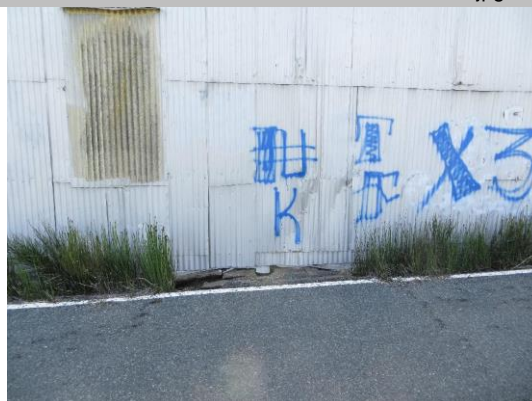
Photo 1 of 3 : UCIP\_FA\_2018\_53355\_73942.jpg

Building on LS shoulder prevents access to LS of levee.

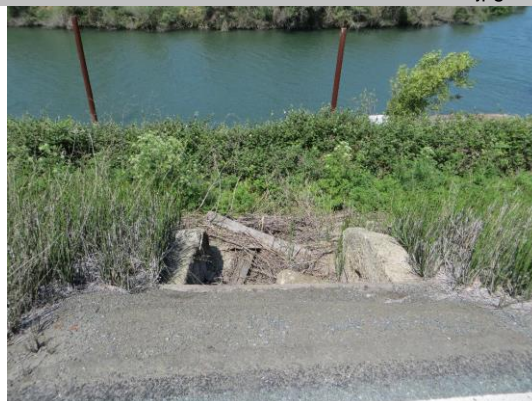
Photo 2 of 3 : UCIP\_FA\_2018\_53355\_73941.jpg

Concrete tunnel and wingwalls visible on WS slope.

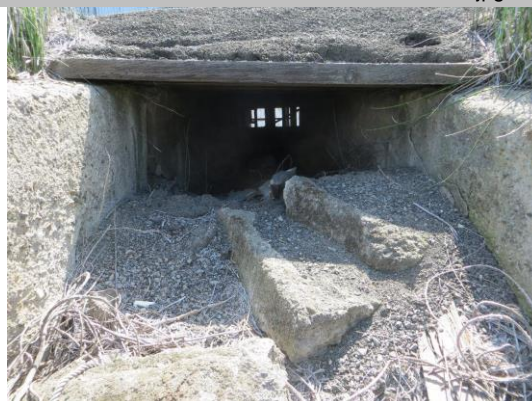
Photo 3 of 3 : UCIP\_FA\_2018\_53355\_73940.jpg

Tunnel open on both ends.

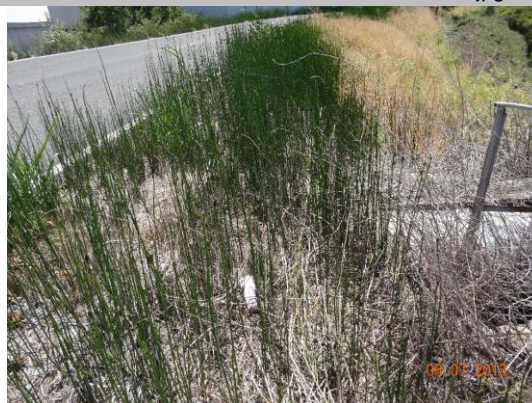
Photo 2 of 3 : UCIP\_FA\_2018\_19662\_33418.jpg

Dense vegetation along the pipe alignment and throughout waterward slope.

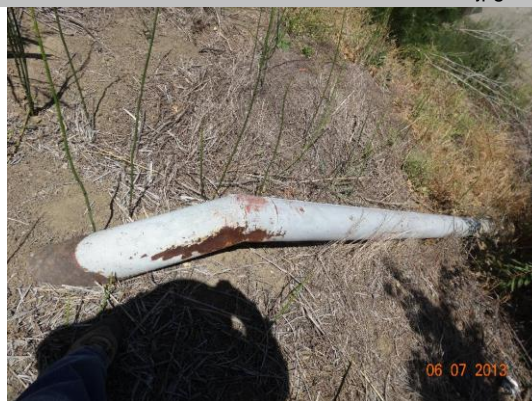
Photo 3 of 3 : UCIP\_FA\_2018\_43524\_33423.jpg

Close up of pipe along landward side.

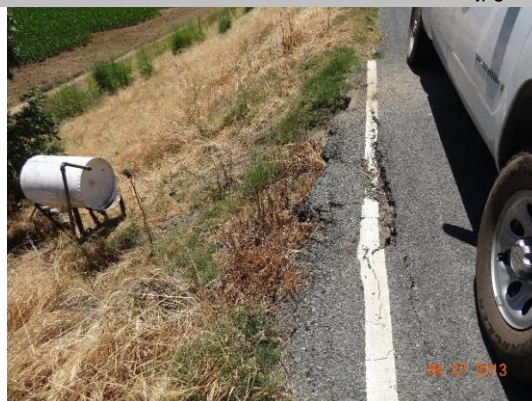
Photo 3 of 3 : UCIP\_FA\_2018\_44876\_33430.jpg

View of landward side. Dry vegetation covers landward slope. Pump system located on landward slope.

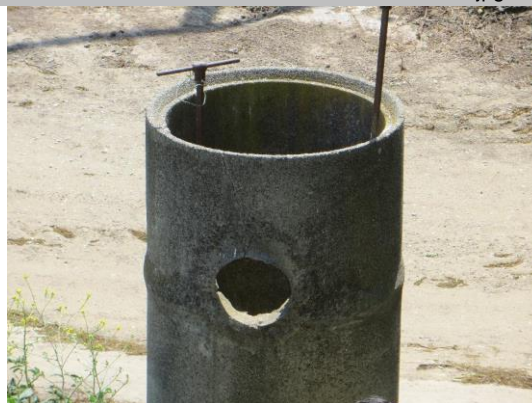
Photo 2 of 2 : UCIP\_FA\_2018\_44746\_73943.jpg

10-inch diameter hole cut in side of standpipe where pipe once was installed.

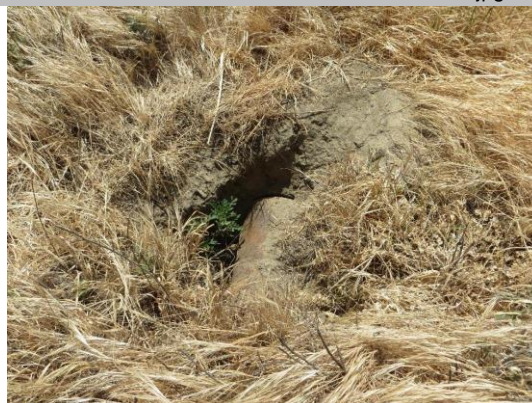
Photo 2 of 2 : UCIP\_FA\_2018\_44877\_73945.jpg

Cut in buried pipe on LS shoulder.

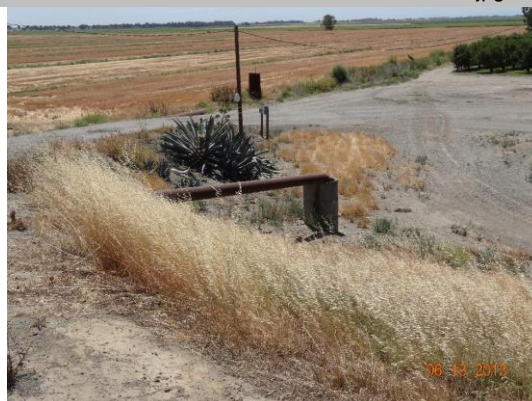
Photo 3 of 3 : UCIP\_FA\_2018\_32542\_59021.jpg

View of landward side. Pipe goes through levee and into concrete standpipe.

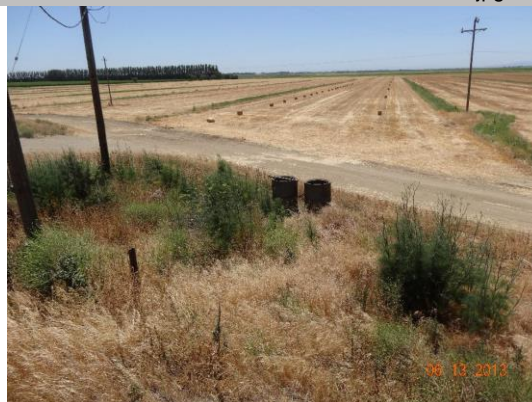
Photo 3 of 3 : UCIP\_FA\_2018\_32544\_59036.jpg

Dry vegetation throughout the landward slope.

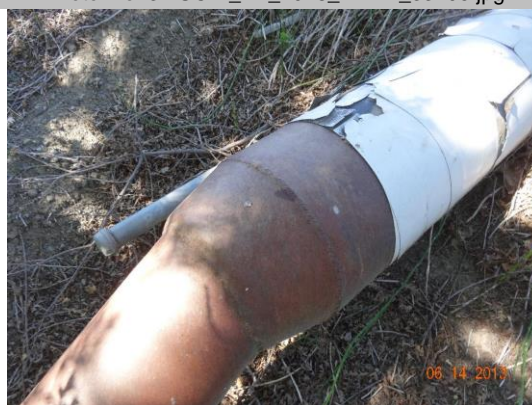
Photo 2 of 3 : UCIP\_FA\_2018\_44471\_33495.jpg

Pipe section reduced at the waterward side daylight.
